# iPad 3G Metal Display Clips Replacement

Replace broken metal display clips on your iPad 3G's front panel assembly.

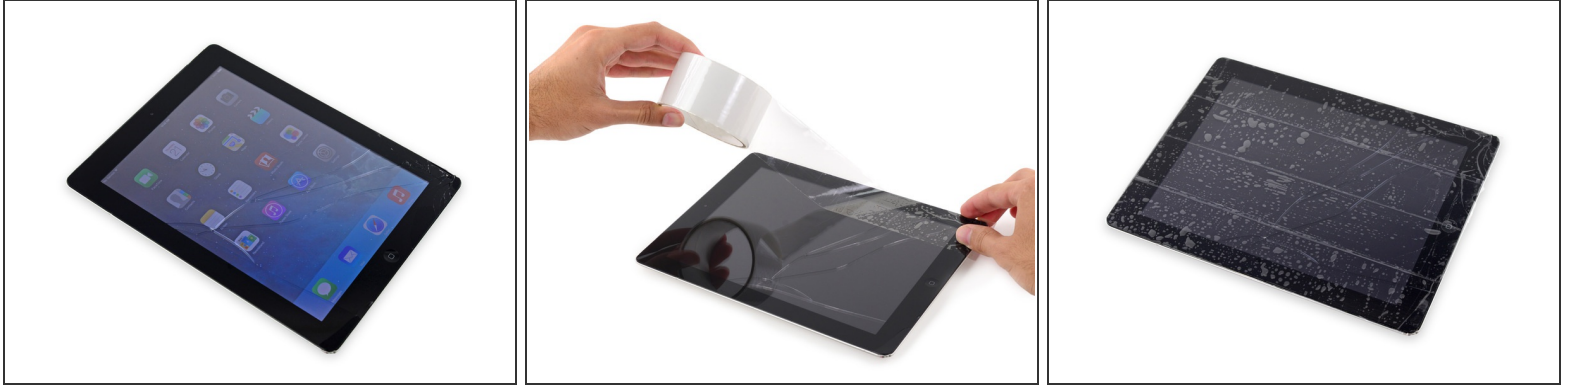
## Step 1 — Display Assembly

- If your display glass is cracked, keep further breakage contained and prevent bodily harm during your repair by taping the glass.
- Lay overlapping strips of clear packing tape over the iPad's display until the whole face is covered.
  - ⓘ This will keep glass shards contained and provide structural integrity when prying and lifting the display.
- Do your best to follow the rest of the guide as described. However, once the glass is broken, it will likely continue to crack as you work, and you may need to use a metal prying tool to scoop the glass out.

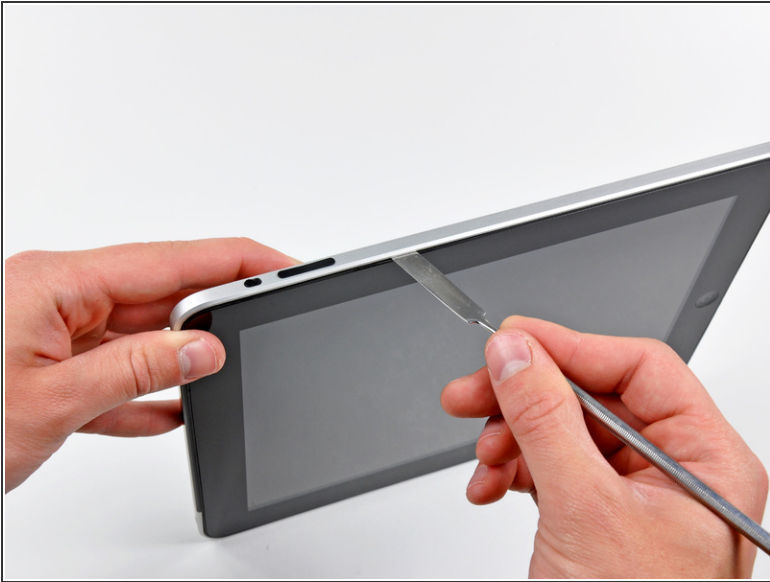
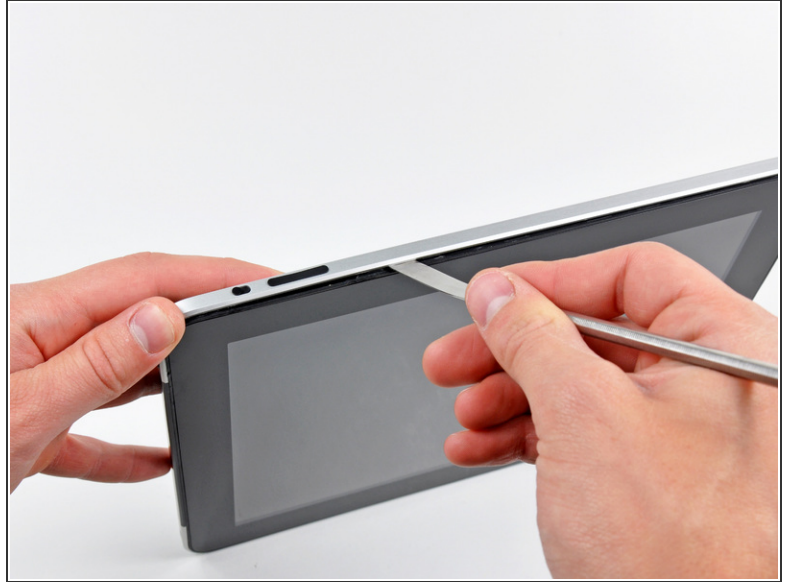
## Step 2

- i** The iPad shown in the photos may look slightly different from your iPad, but the procedure is the same.
- Insert a metal spudger between the right edge of the display assembly and the rear panel assembly.
  - Rotate the spudger away from you to release the tabs along the top edge of the display.

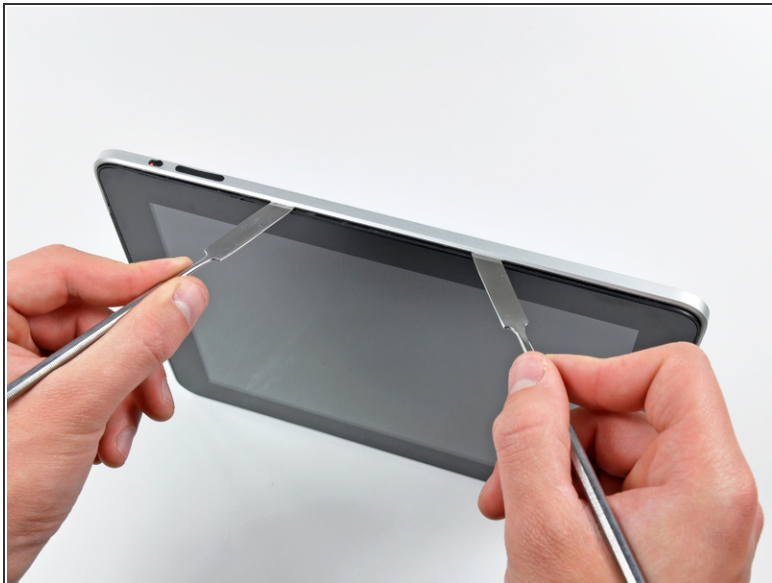
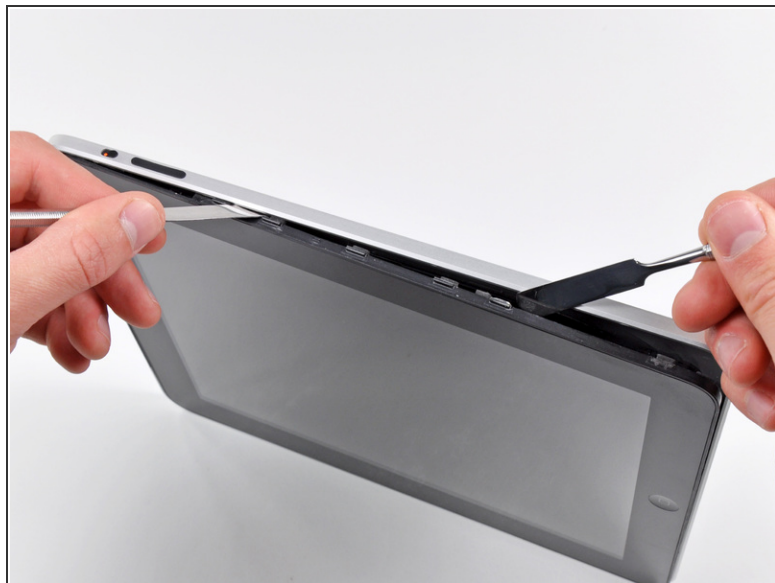
## Step 3

- Insert a second metal spudger between the top edge of the display assembly and the rear panel assembly to keep the tabs from snapping back into place.
- Pry the display assembly away from the rear panel.

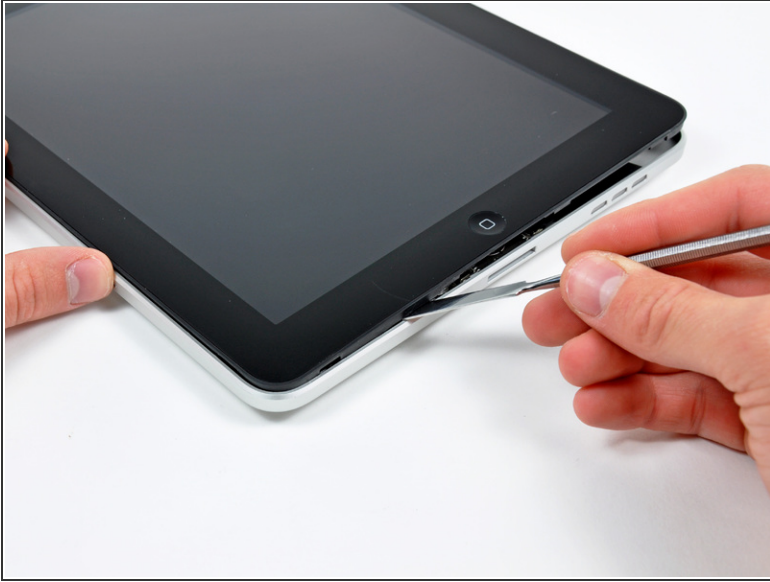
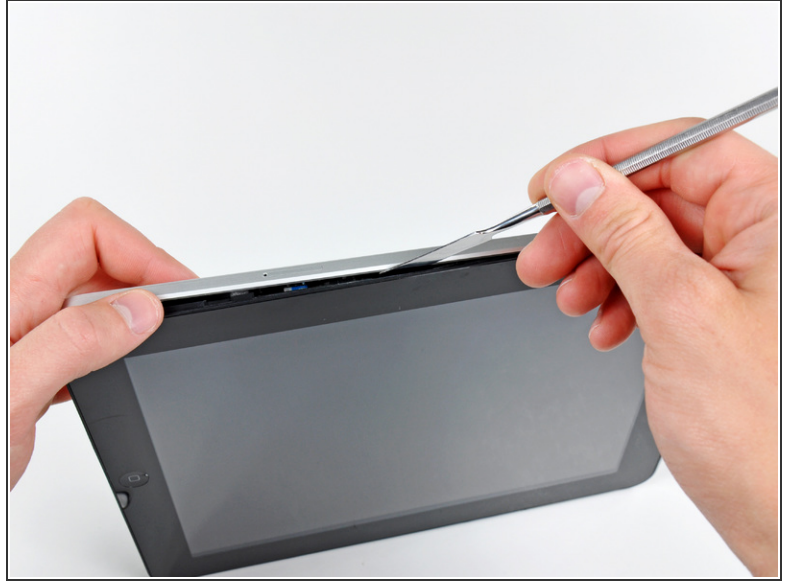
## Step 4

- Continue prying the display assembly away from the rear panel along the bottom and left edges of the iPad.

Use extreme caution as you approach the top edge of the iPad. The digitizer ribbon cable is located near the edge of the rear panel and can easily be damaged.

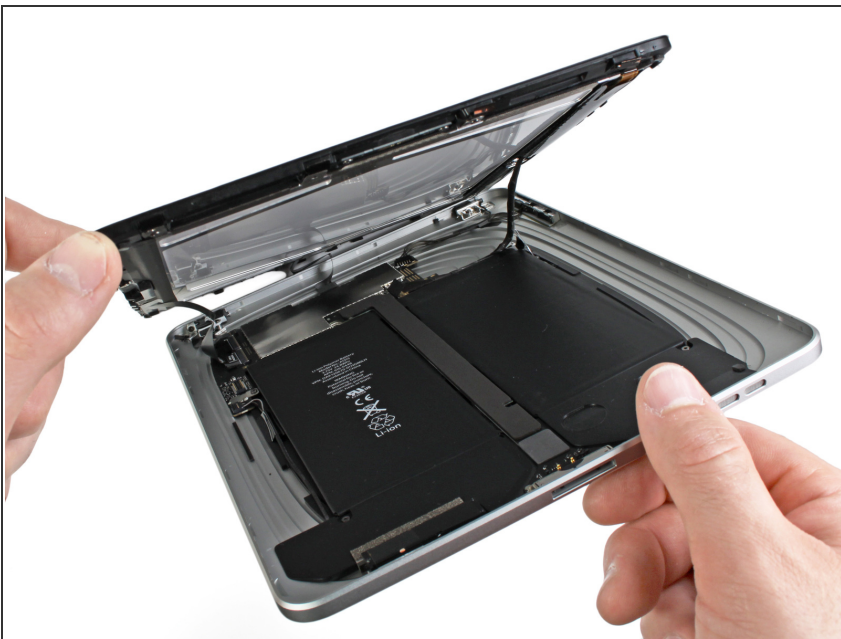
## Step 5

- Lift the display assembly away from the rear panel assembly by its bottom edge.

Do not excessively lift the display assembly off the rest of the iPad, as a fragile antenna cable with very little slack still connects the two components.

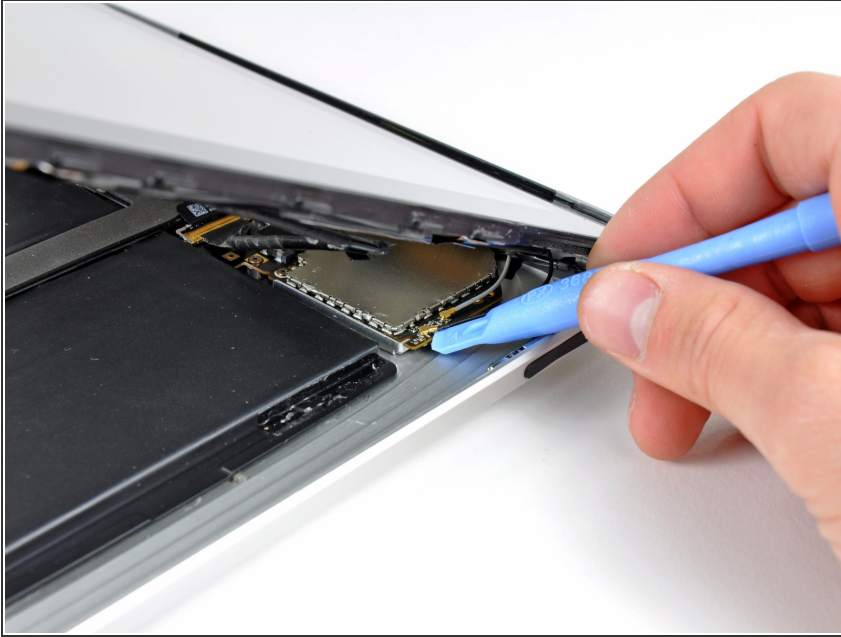
## Step 6

- Use the flat end of a spudger to pry the antenna connector closest to the bottom of the iPad up off its socket on the communications board.

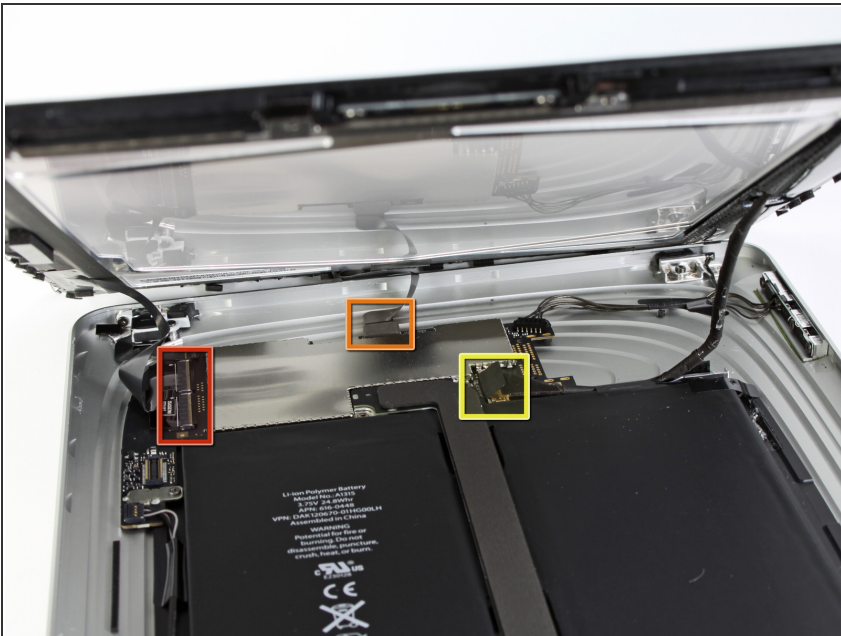
## Step 7

- In the following steps, you will disconnect the three cables attaching the display assembly to the logic board. The cables are for the following components:
  - Digitizer
  - Ambient Light Sensor
  - Display Data Cable

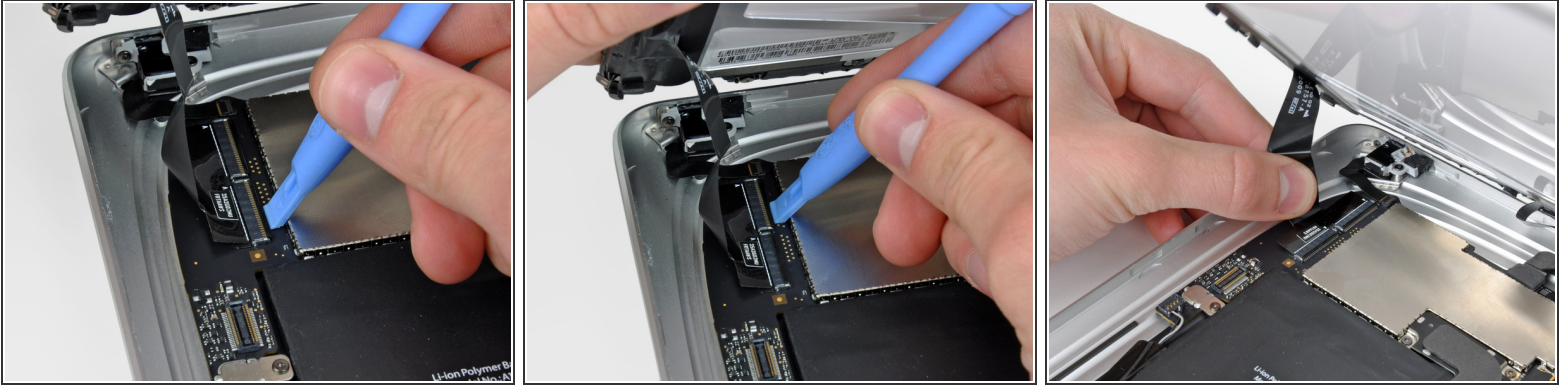
## Step 8

- Use the edge of an iPod opening tool to flip up the retaining flaps holding the digitizer ribbon cables in their sockets on the logic board.

⚠ Be sure you are flipping up the retaining flap, **not** the socket itself.

- Pull the digitizer ribbon cables straight out of their sockets.

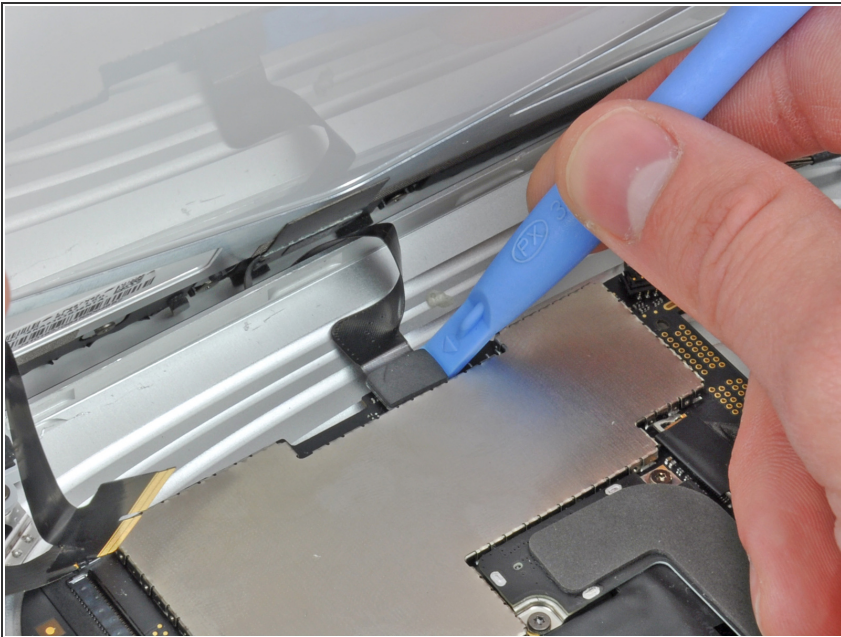
## Step 9

- Use an iPod opening tool to remove the ambient light sensor connector from its socket by gently prying upward.

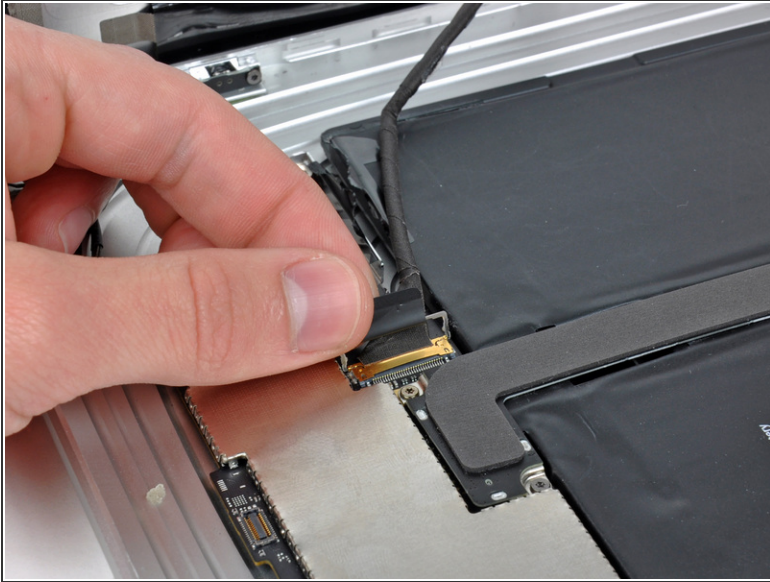
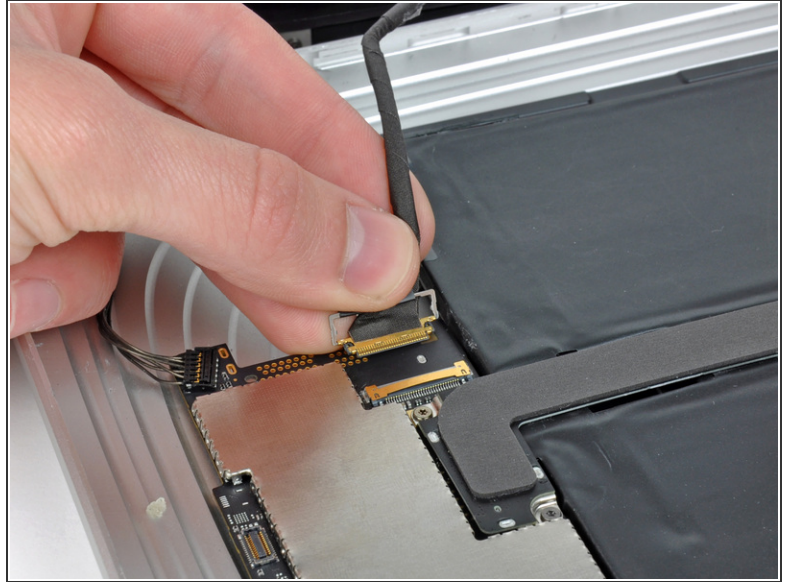
## Step 10

- Disconnect the display data cable from the main board by flipping up the metal retainer by its black plastic pull tab.
- Pull the cable connector away from its socket.
- ⓘ Pull the connector parallel to the face of the logic board.

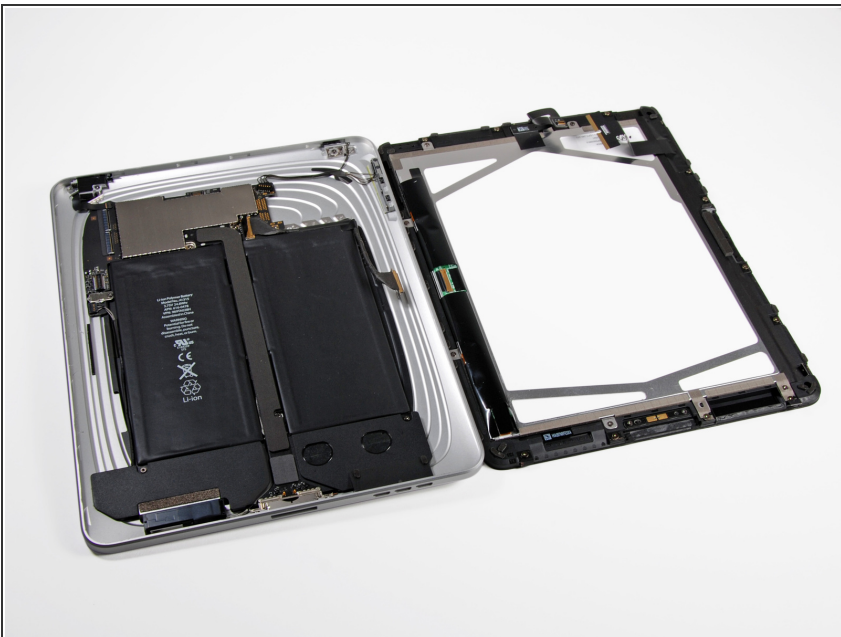
## Step 11

- Remove the display assembly from the rear panel assembly.

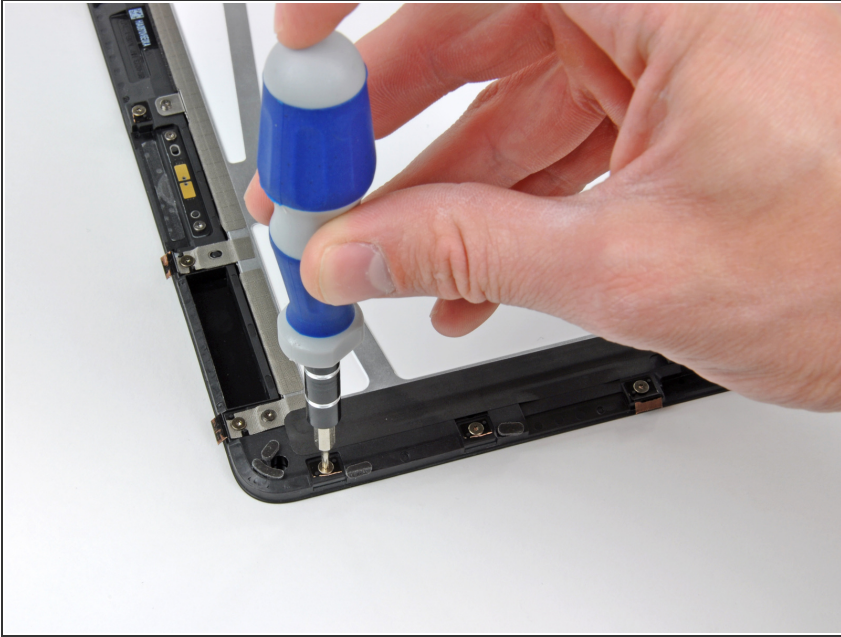
## Step 12 — Metal Display Clips

- During the display assembly removal process, it is highly likely that the metal clips around the perimeter of the display assembly will break.
  - To replace a broken clip, first remove the T5 Torx screw securing the broken base of the clip to the display assembly.
  - Place a new clip on the positioning pins molded into the display frame, and reinstall the T5 Torx screw to secure the two pieces together.
-

Repeat this process for any other broken clips around your display assembly.
